VUMOP STUDY SITE: Čechtický stream catchment

LOCATION & LANDUSE

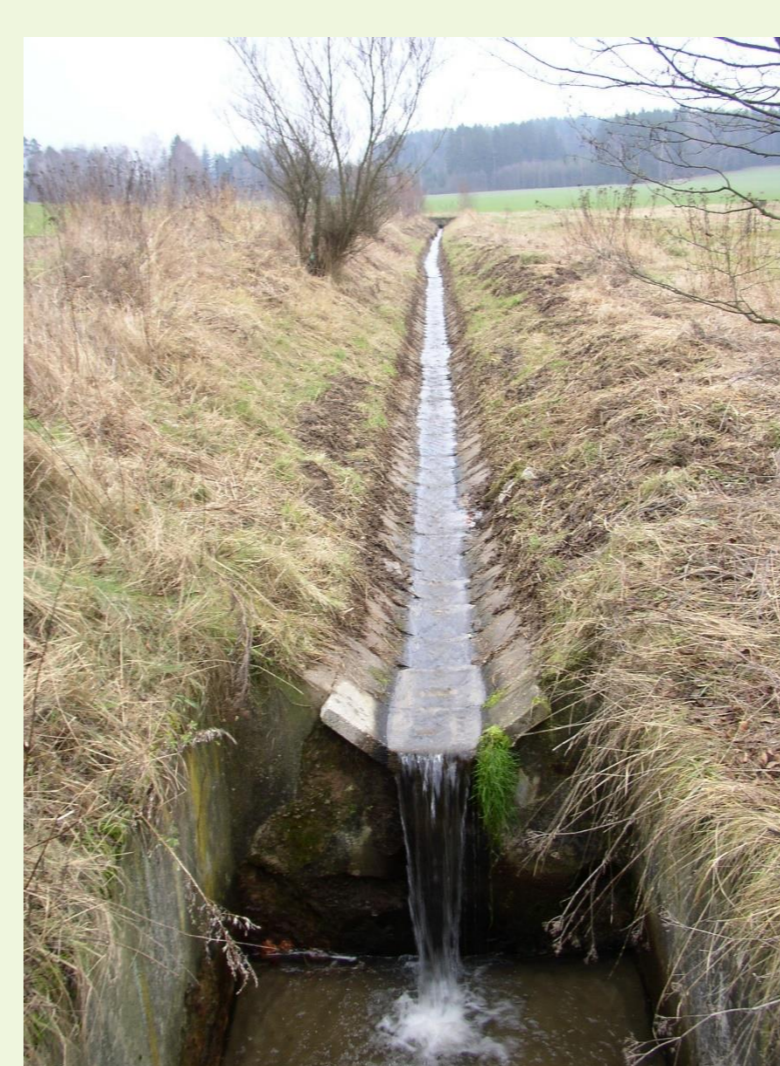
◀ Straightened and deepened small waterways

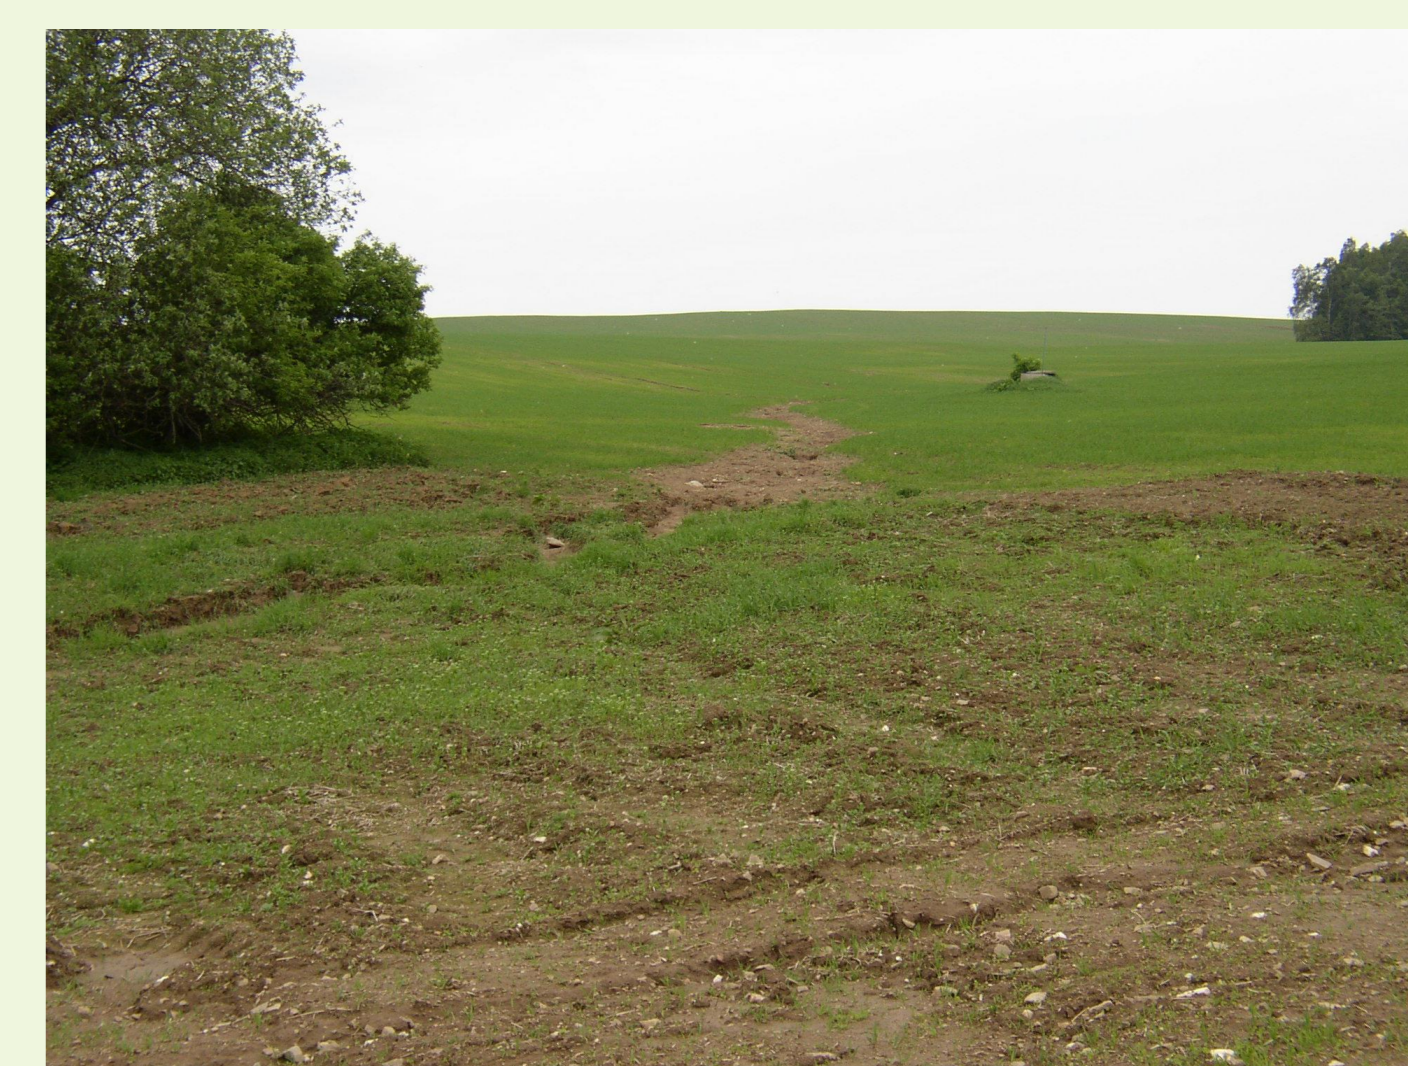
Soil erosion on large field blocks, even on gentle slopes

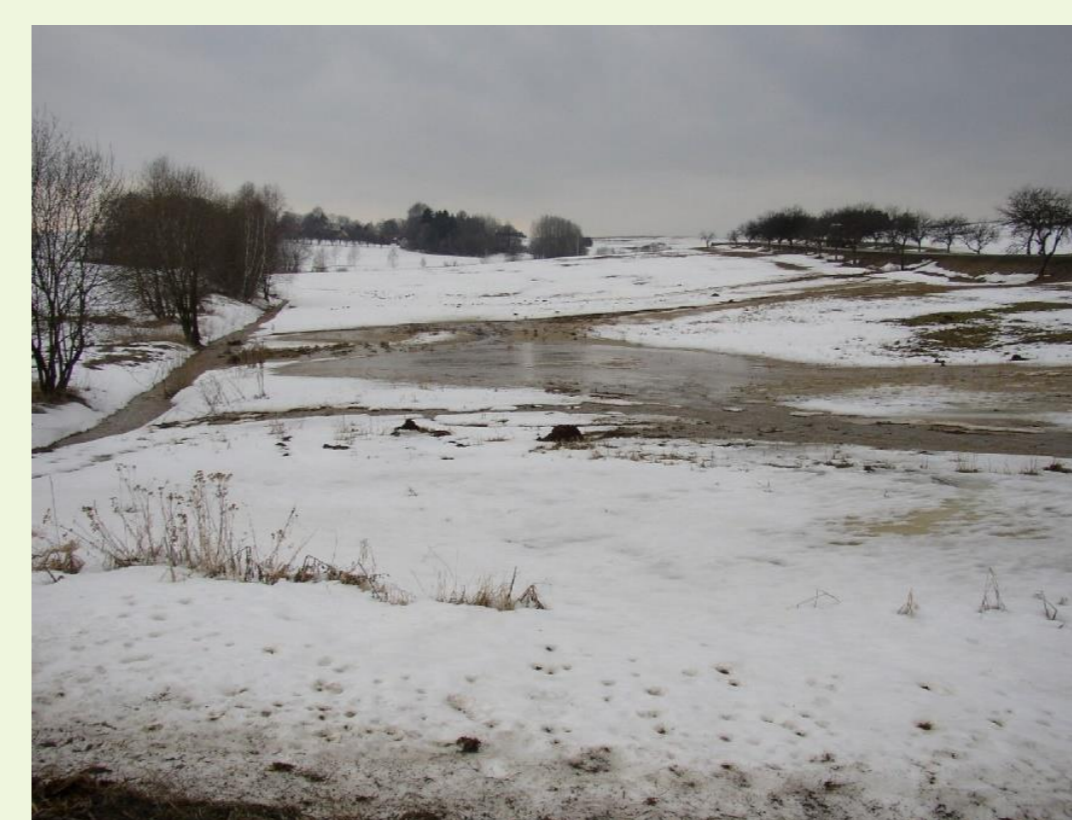
◀ Overland flow from snowmelt and due to neglected maintenance of land drainage, wrong management and large filed blocks

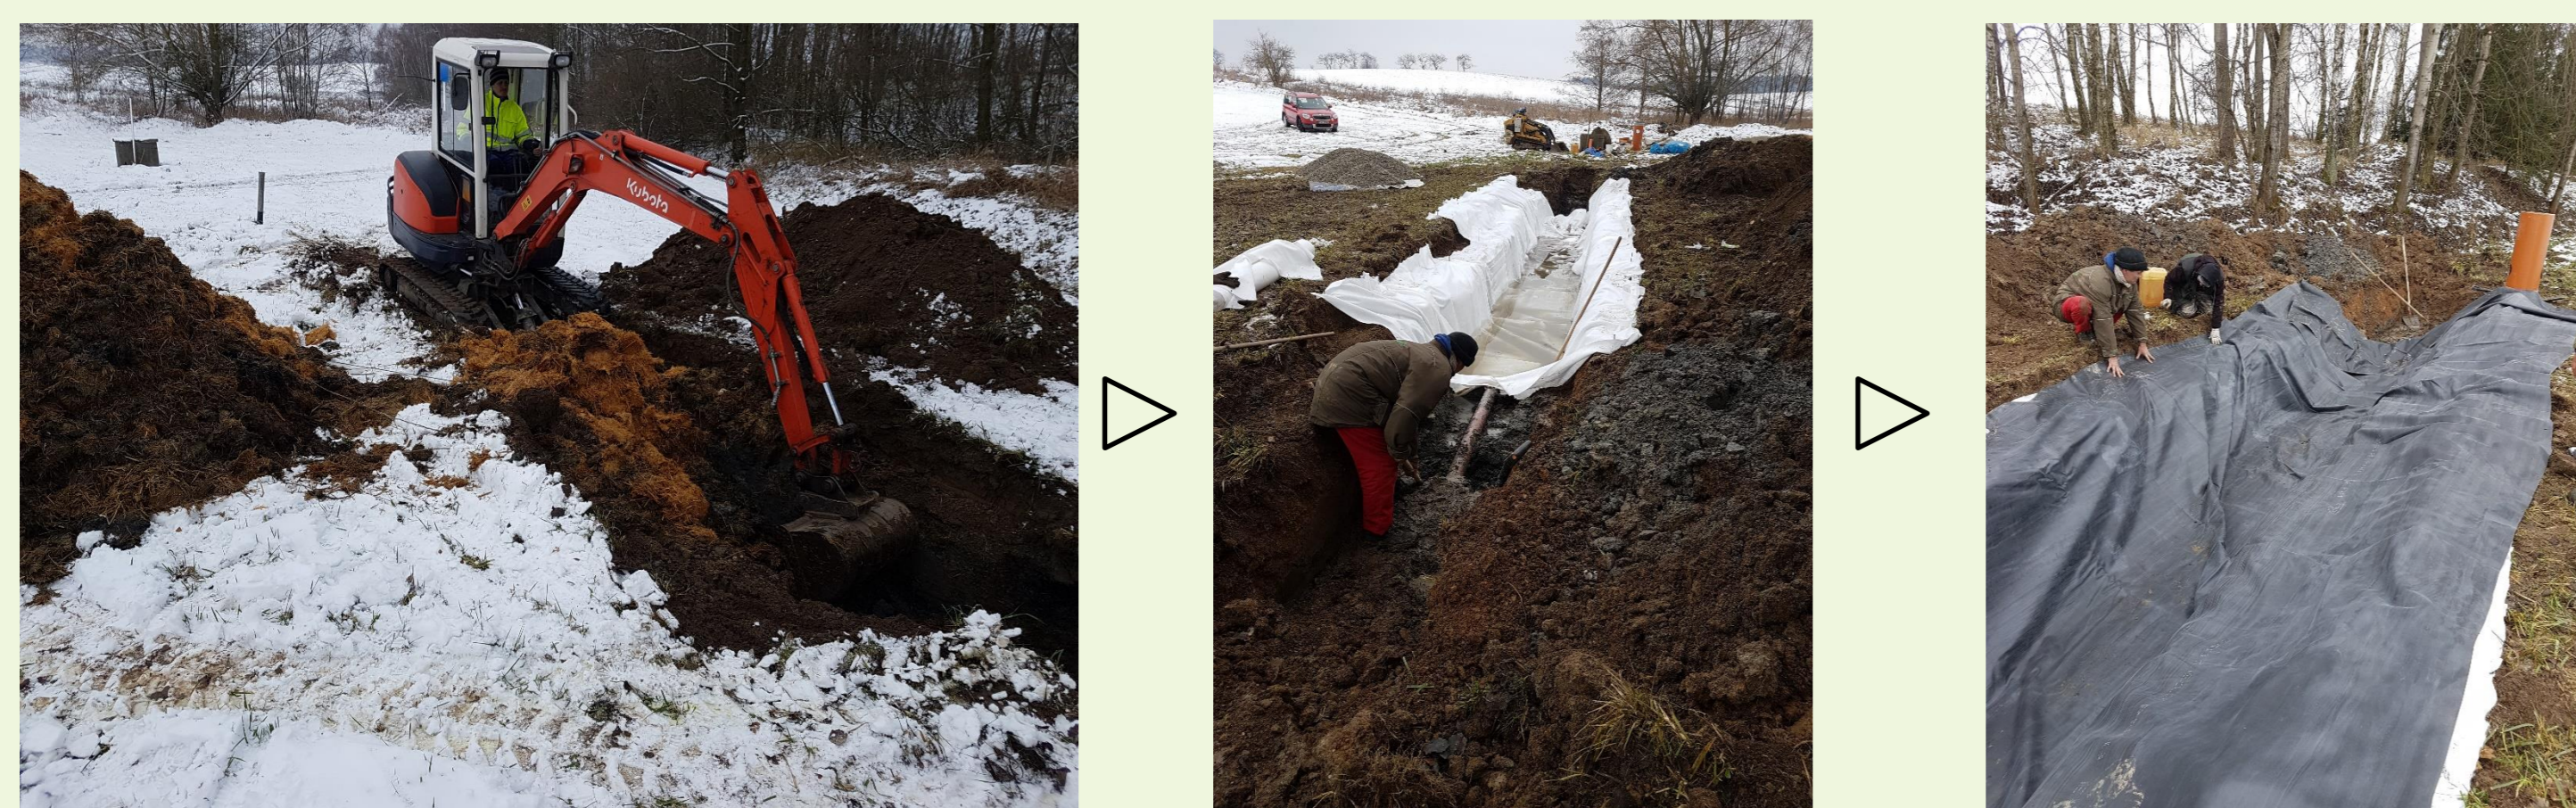
VUMOP experimental denitrifying bioreactor for treatment of tile drainage water. In 2019, the old wheat straw substrate was replaced with a mixture of gravel and birch woodchips (10:1). Not in use commonly in the catchment; a measure with a large application potential.

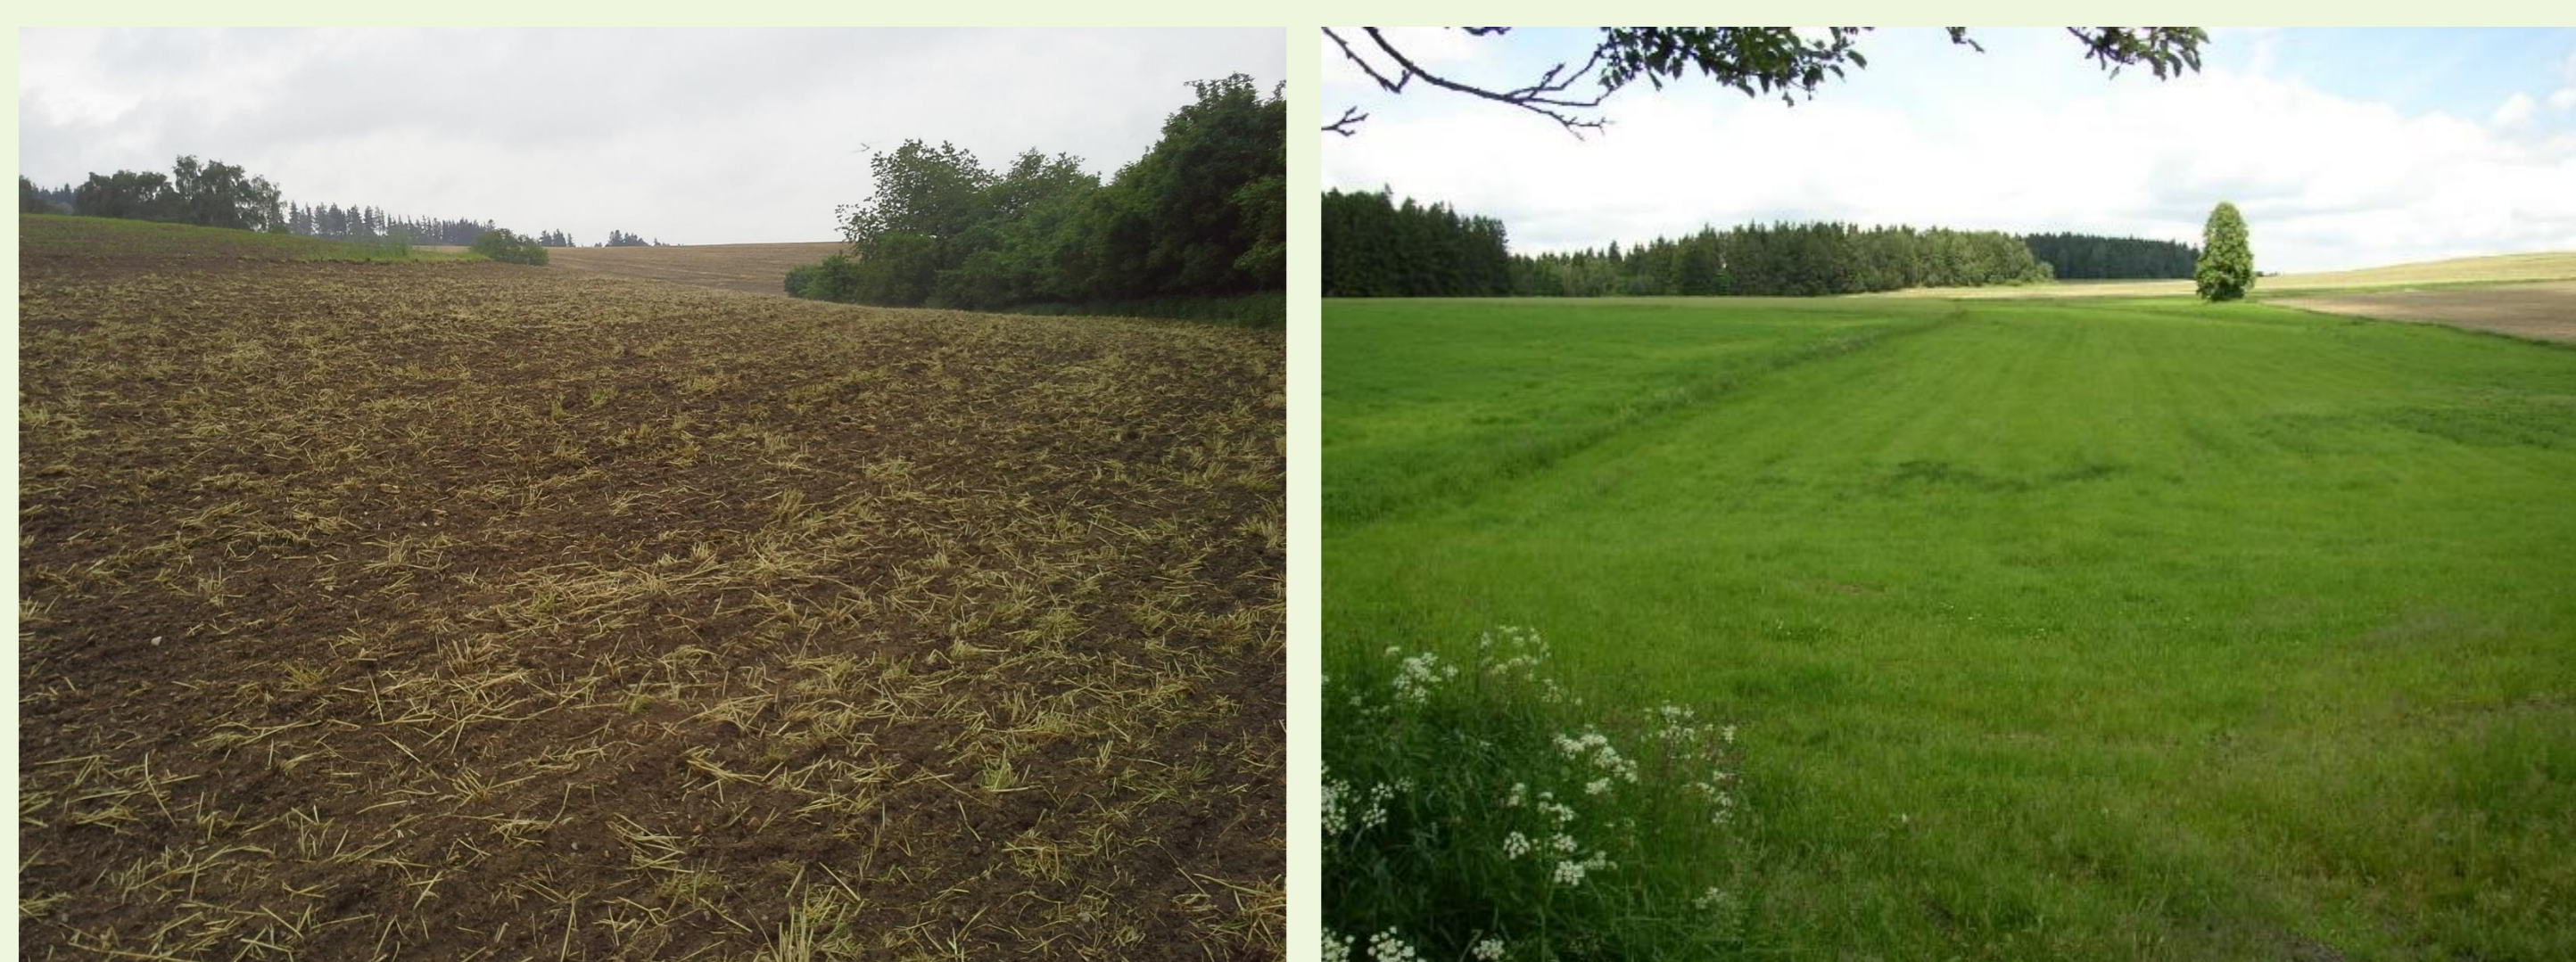
Some farmers apply conservation tillage, especially for maize (no-till, strip-till)

At some sites - grassed wet soils and waterways. End-of-field grassed buffers.
