# ATK STUDY SITE: Csorsza, Hungary

Ágota Horel, Györgyi Gelybó, Emese Ujj, Péter Braun, Brigitta Szabó (Tóth)

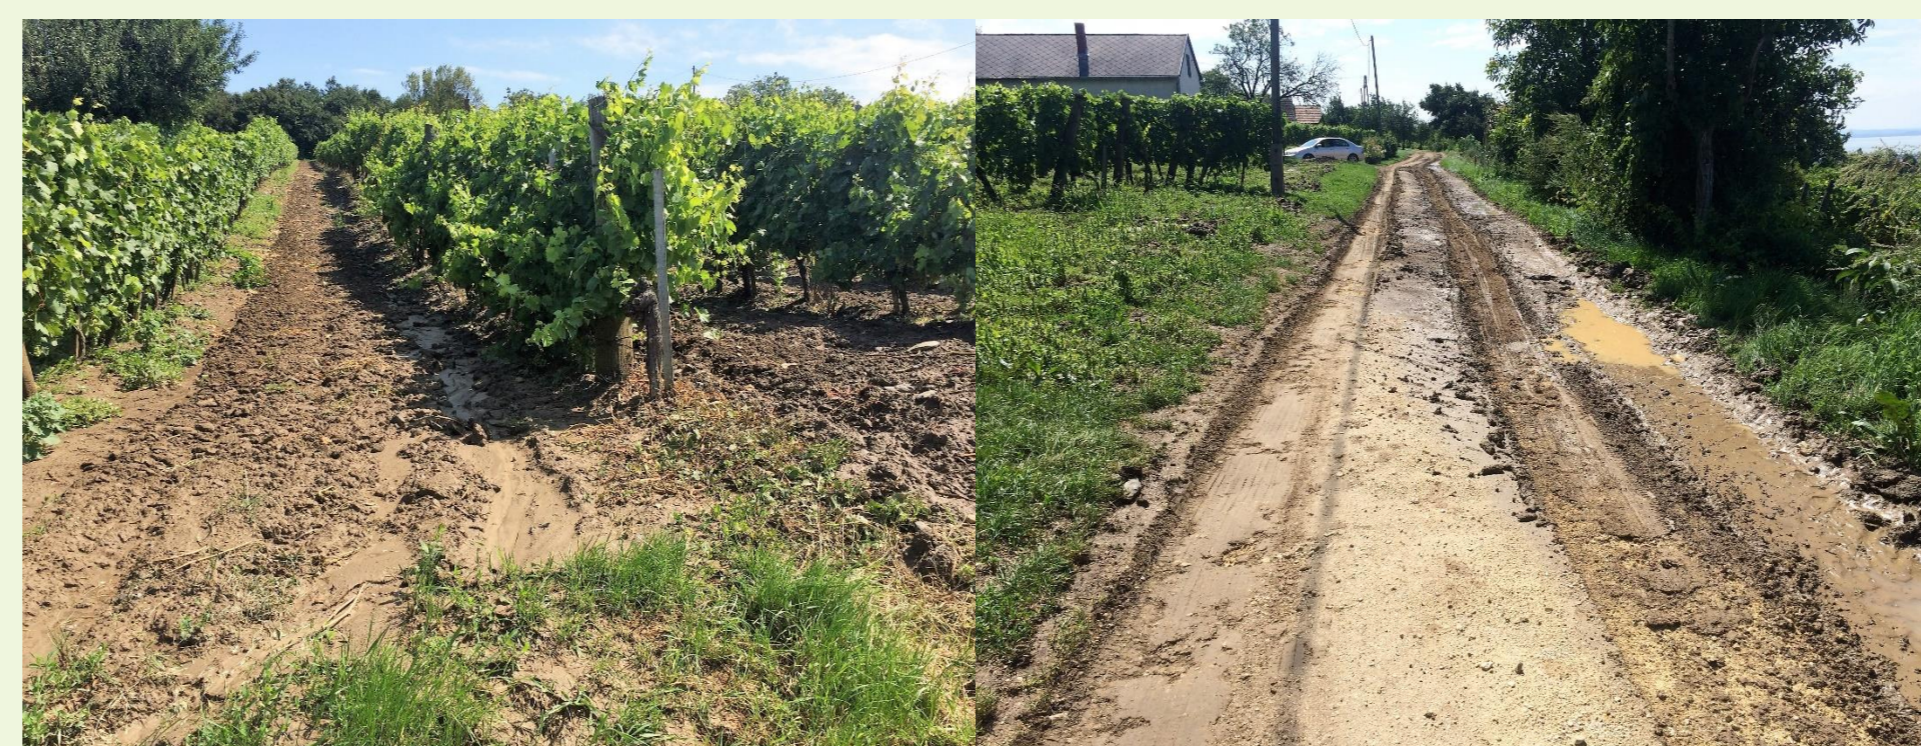
▷ Young grapes with tilled in rows – high erosion

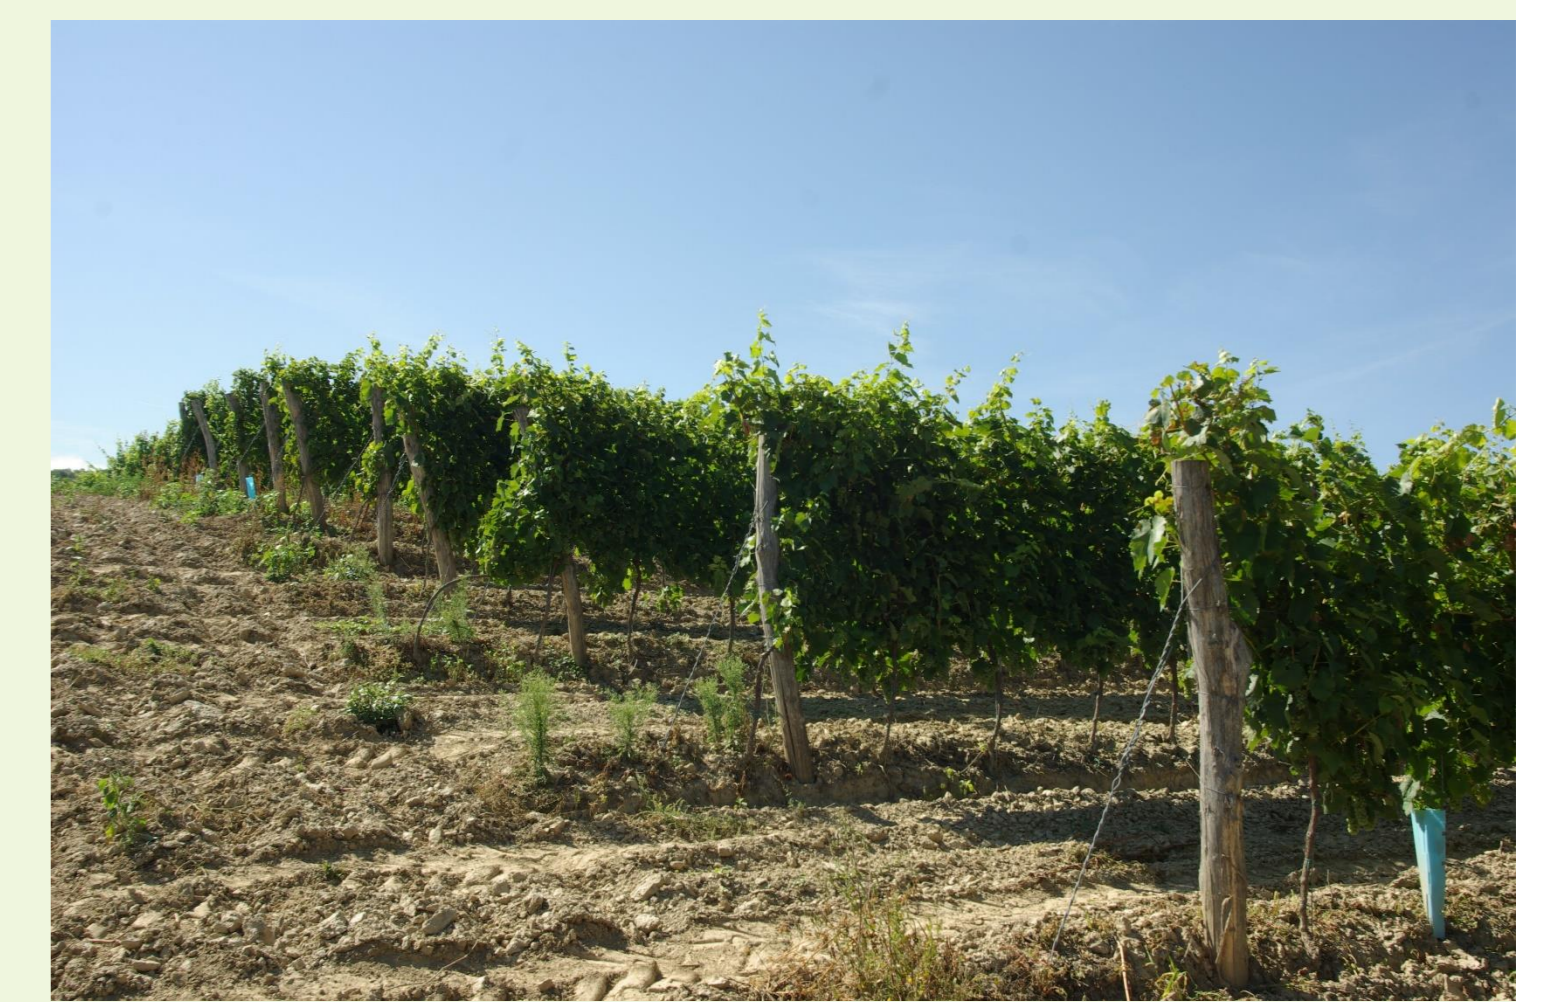
Soil erosion on bare soil surface ◁

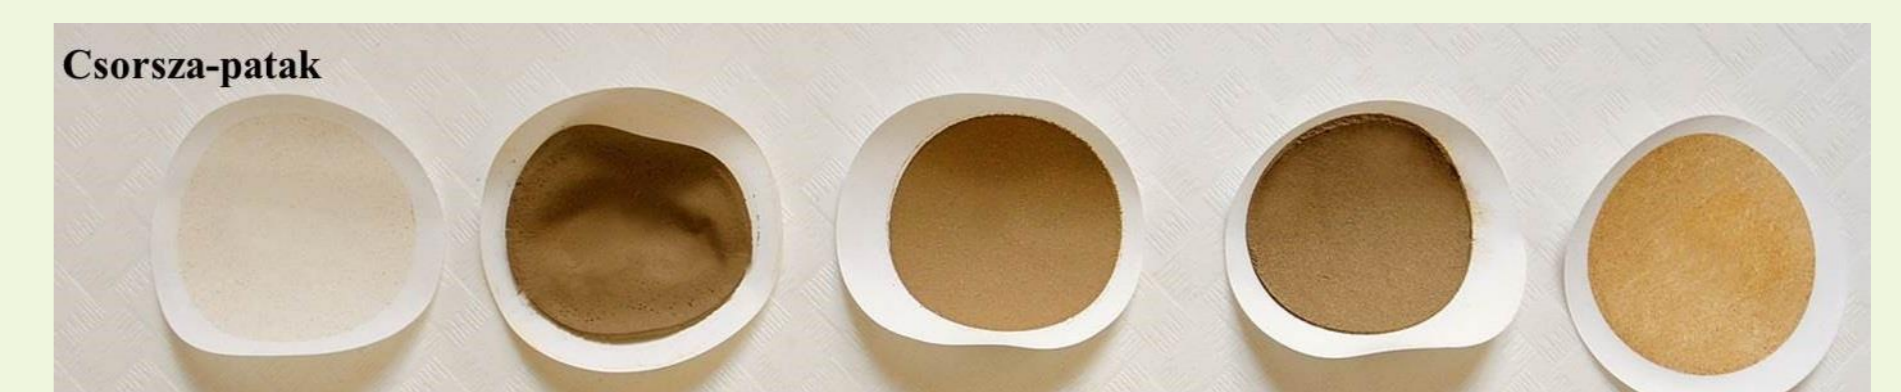
Snow melt resulted total suspended sediment (TSS) leaving the catchment ◁

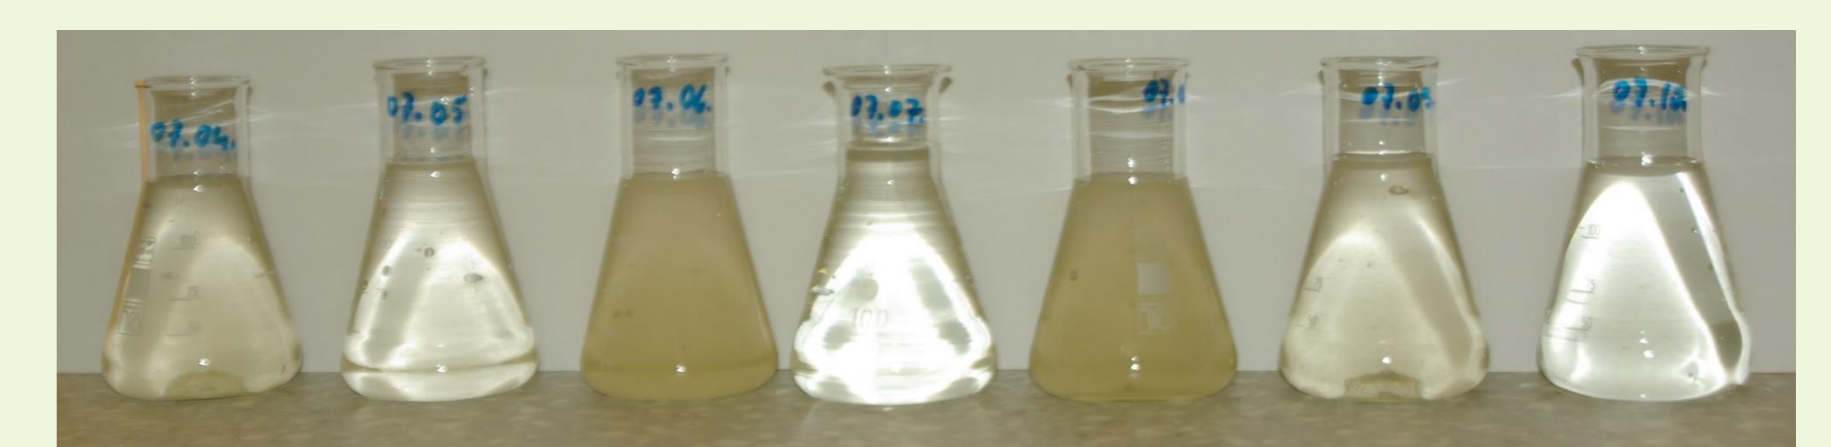
Small rain event resulted increase in TSS ◁

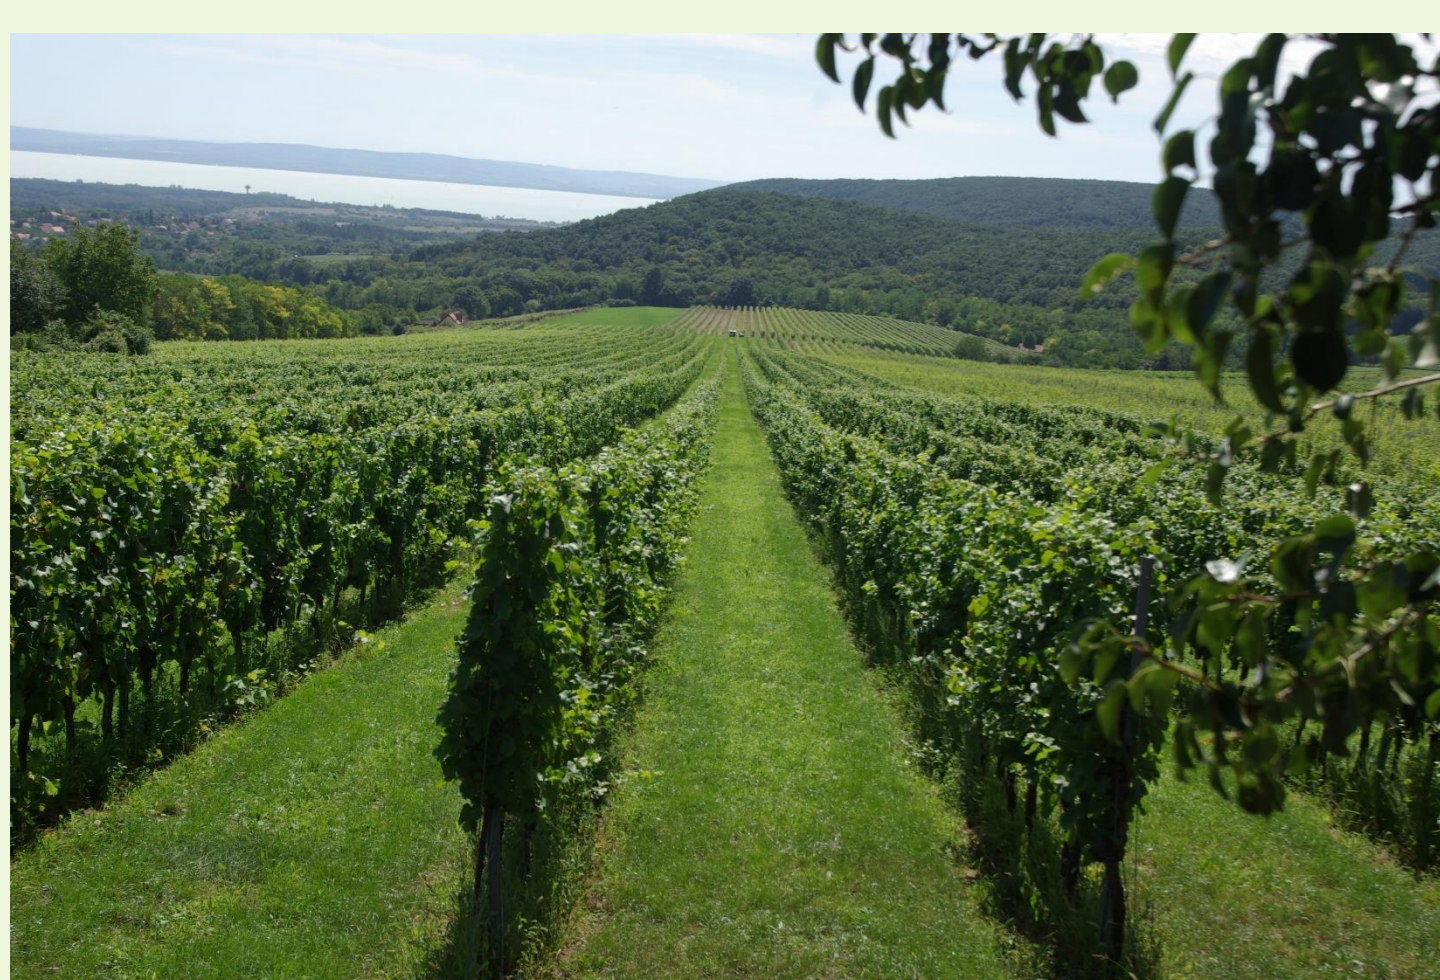
▷ Grass between rows

- Grass stripes between field plots
- Dam placed at lower areas to catch eroded soil – mechanically moved back to the top of the slopes
- Older grapevines have no tillage – grass
- Green manure instead organic or inorganic fertilizer
- Organic wine farm

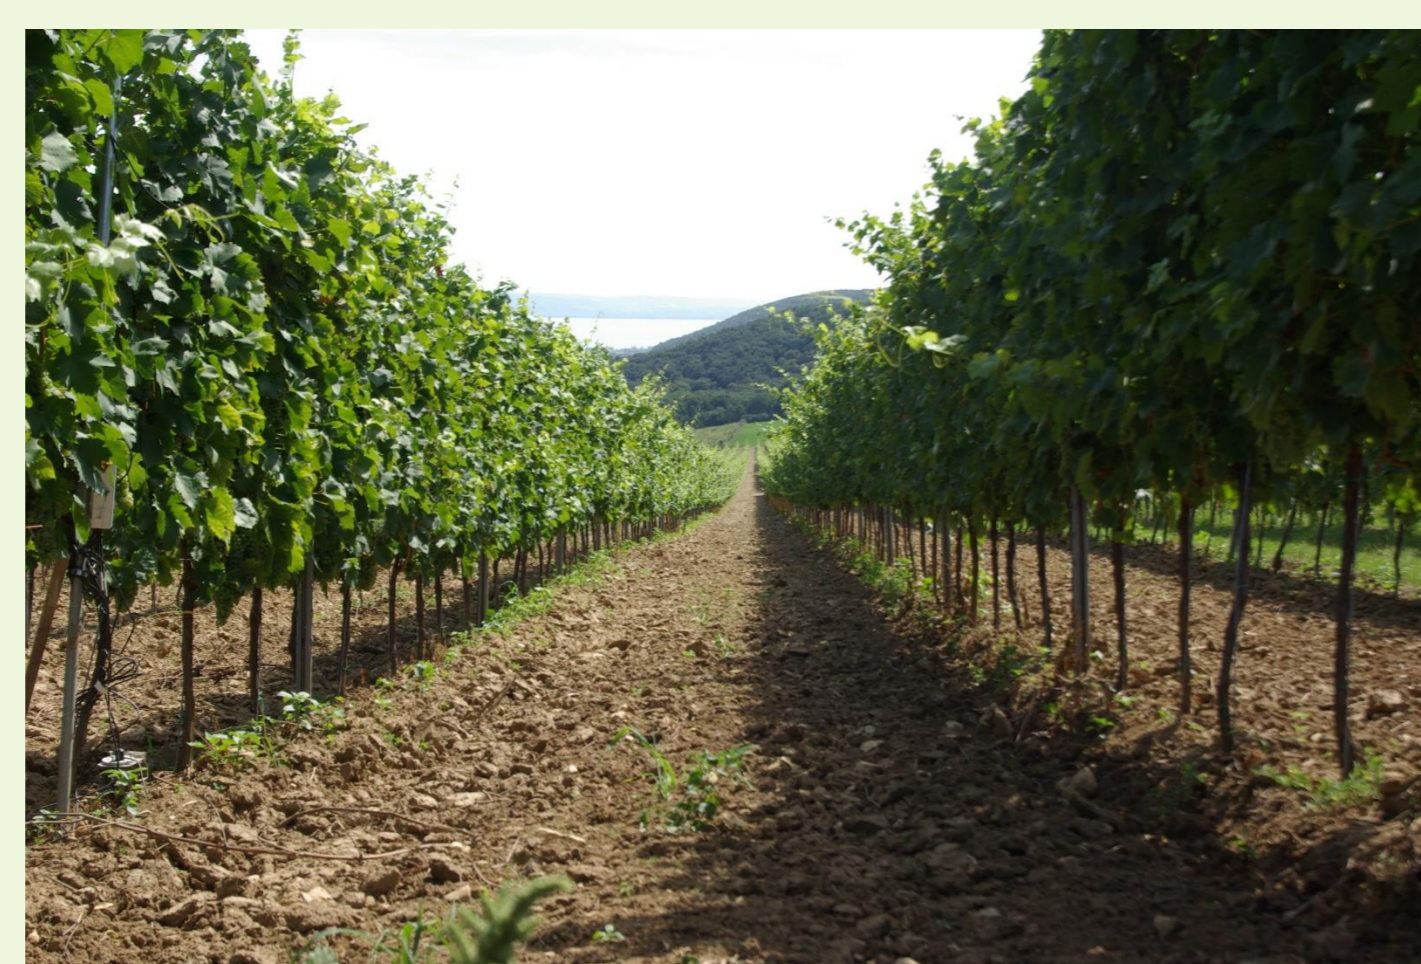
Green manure addition to tilled rows ◁

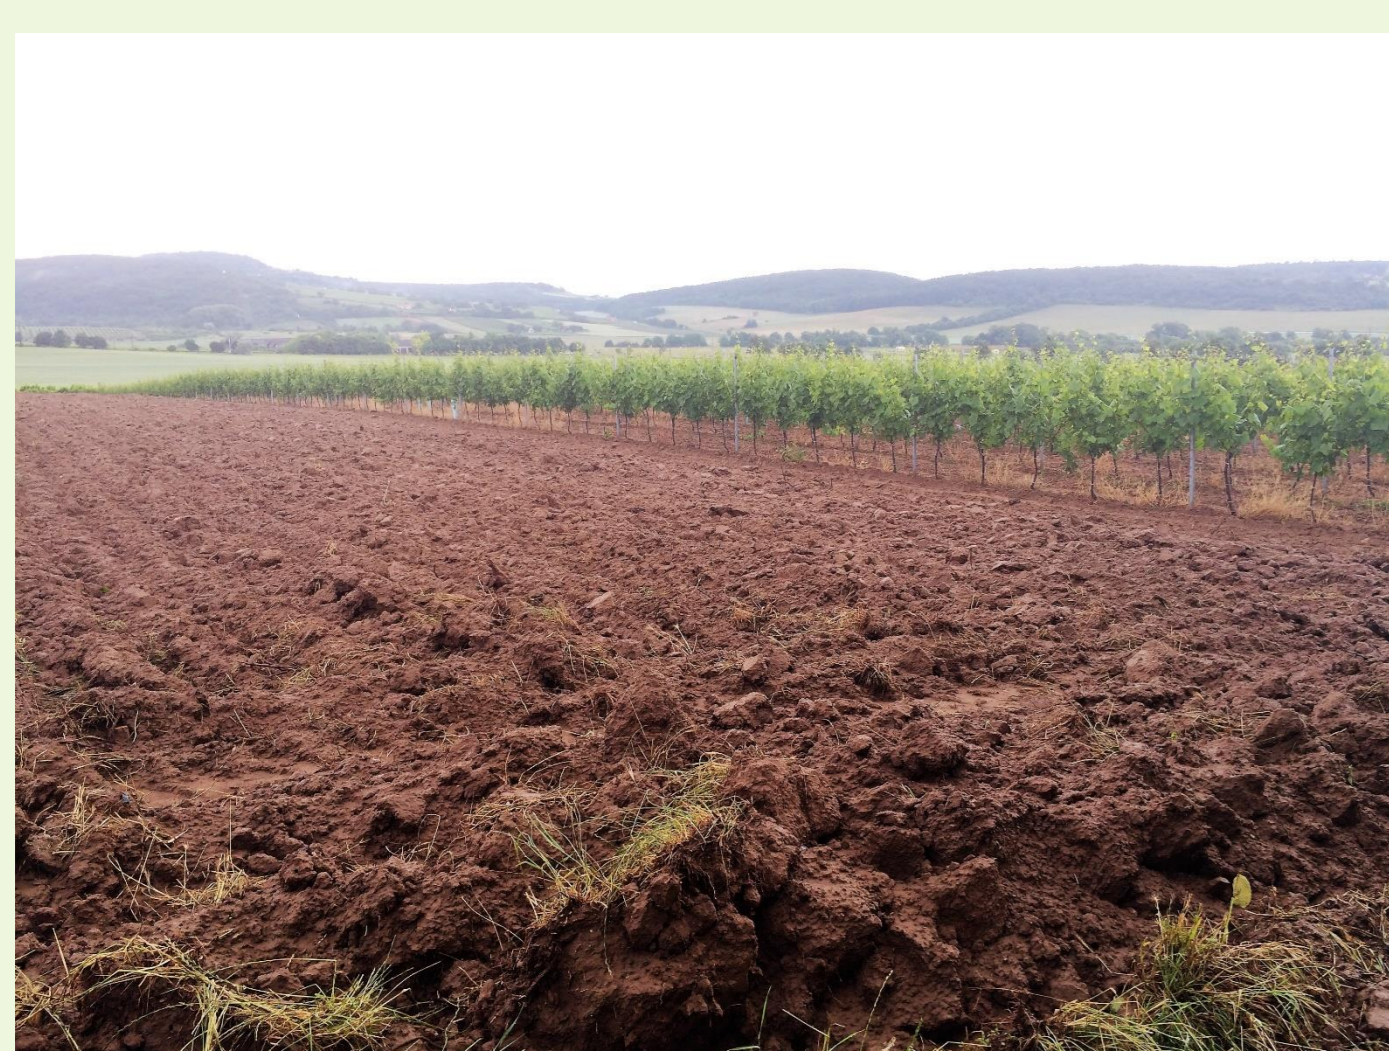
▷ Reduce tillage when possible
